TEST REPORT

Report Number: 1033-07001-002

Sample Description: Plastic Whirlpool Bathtub with Pressure Sealed Doors

Model: E&M
60" x 35-1/2" x 19-1/4"

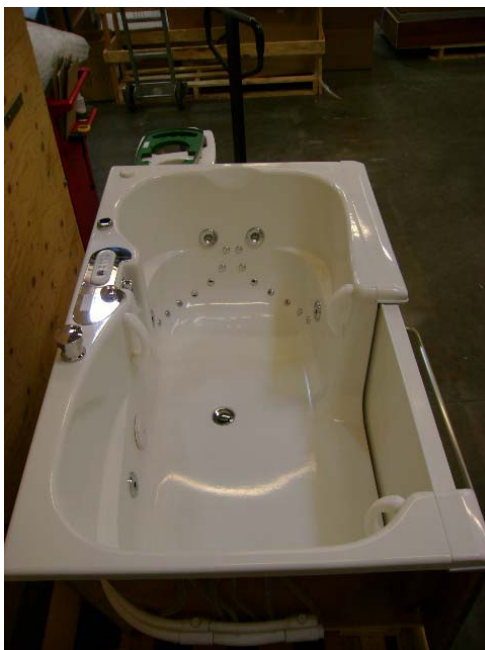
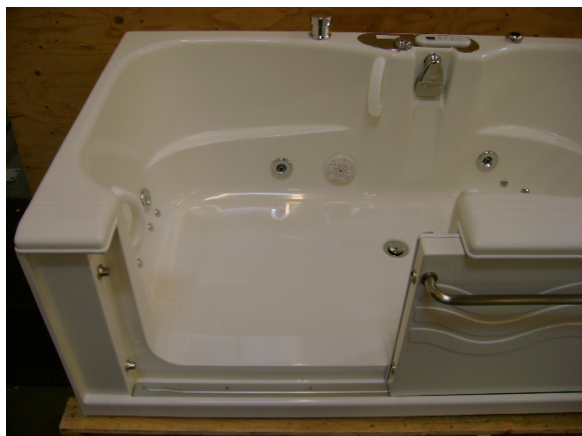
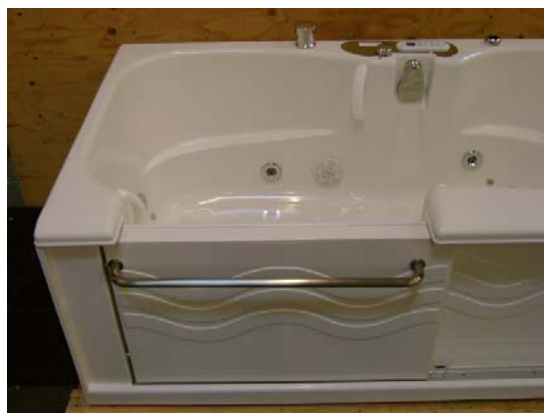
PHOTOGRAPH OF SAMPLE TESTED:

Unit tested is a plastic whirlpool bathtub with one pressure sealed door. The bathtub is made from gel coat with fiberglass reinforced backing. The whirlpool system consists of one pump and Vico thin suction fitting and seven jets with rigid PVC piping as well as flexible hoses as plumbing.
